ANNUAL REPORT
OF THE
LIGHT-HOUSE BOARD

TO THE
SECRETARY OF THE TREASURY

FOR THE
FISCAL YEAR ENDED JUNE 30, 1893.

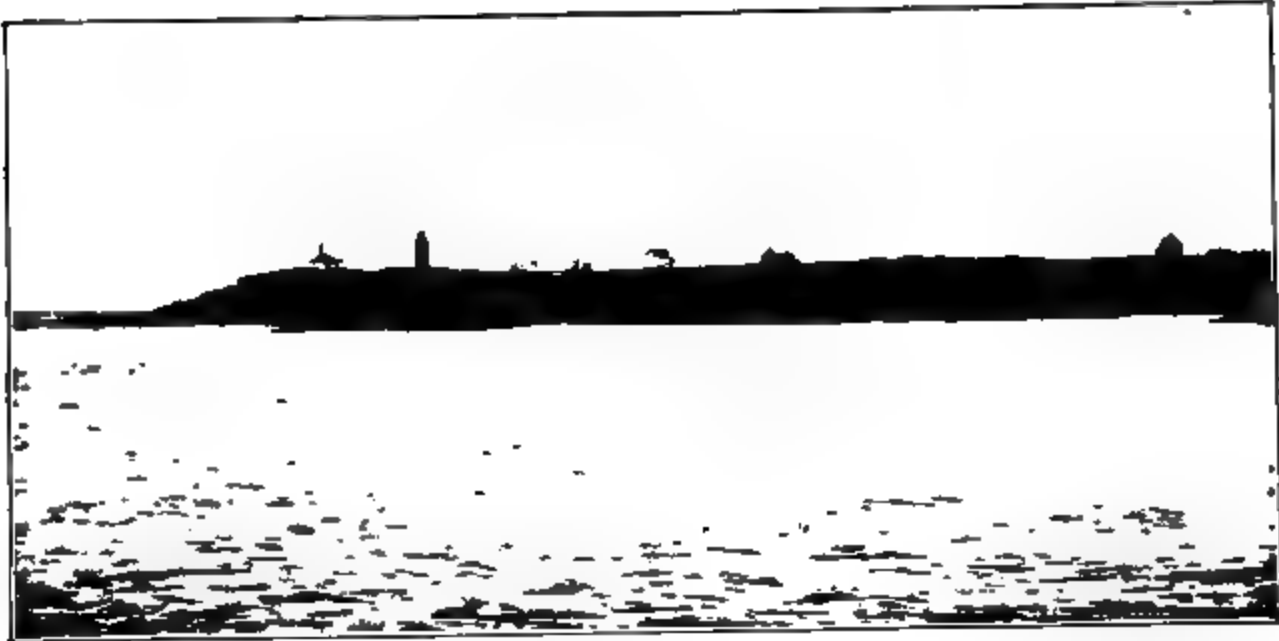
LIBBY ISLANDS LIGHT-STATION, LOOKING NW.

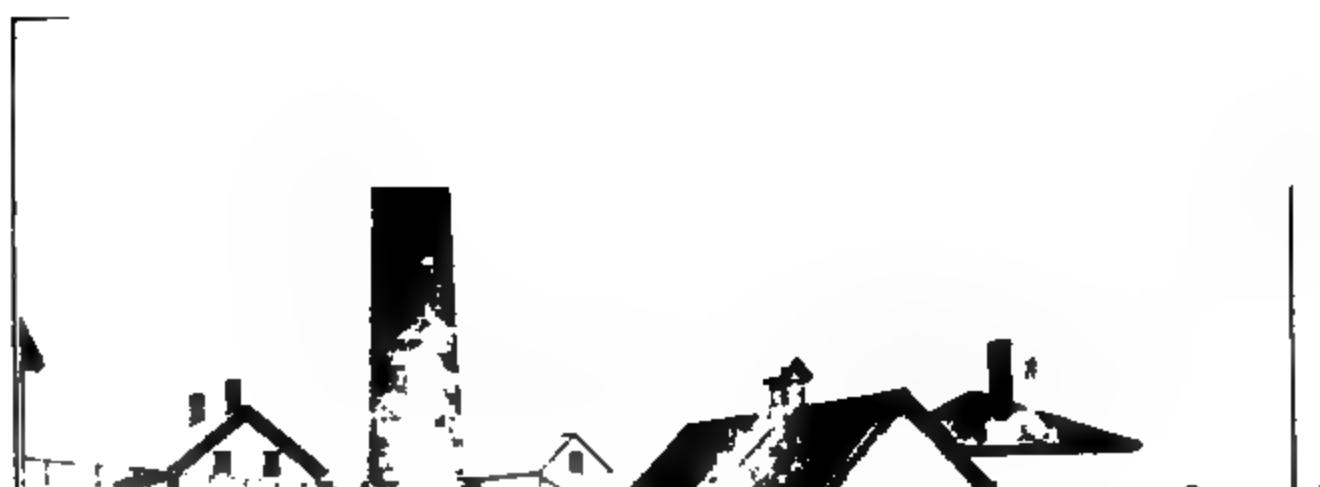
PETIT MANAN LIGHT-STATION, LOOKING NE.

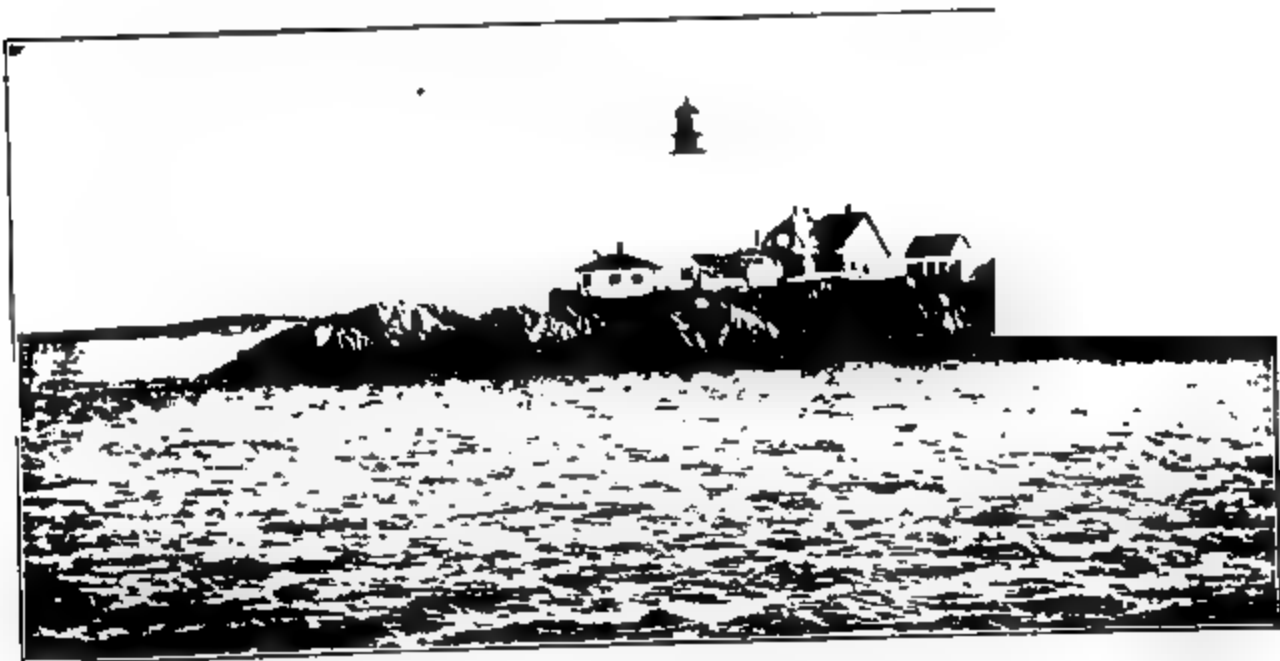
PORTLAND HEAD LIGHT-STATION, LOOKING SW.

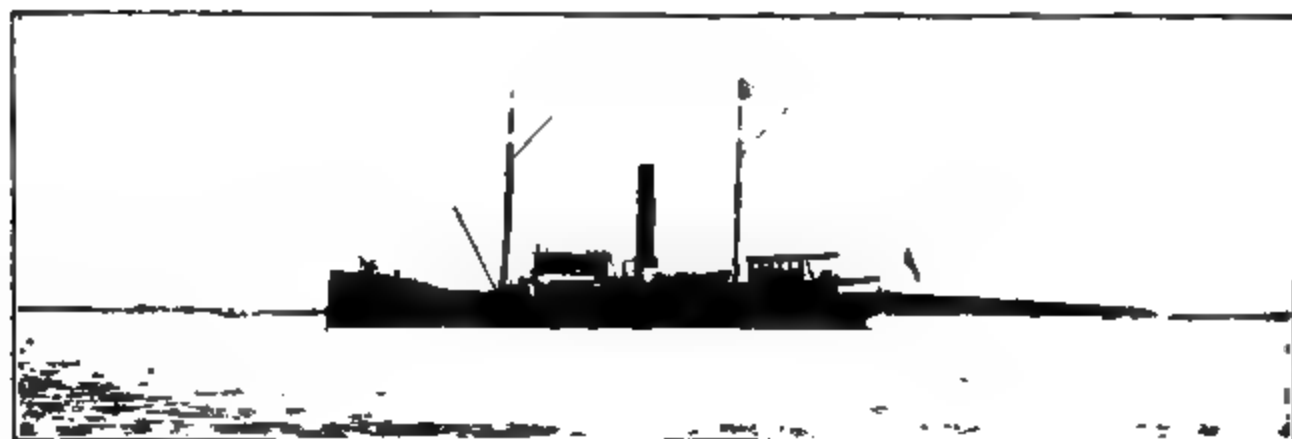
LIGHT-HOUSE TENDER MYRTLE, 1893.
